Monitoring Data Record

Project Title: R-210A (Site 10) COE Action ID: 1993-0-0570

Stream Name: Unnamed tributary to the Little River DWQ Number: 010404

City, County and other Location Information: US 1 (Vass Bypass) in Moore County  
(Sta. 51+70 to 52+20)

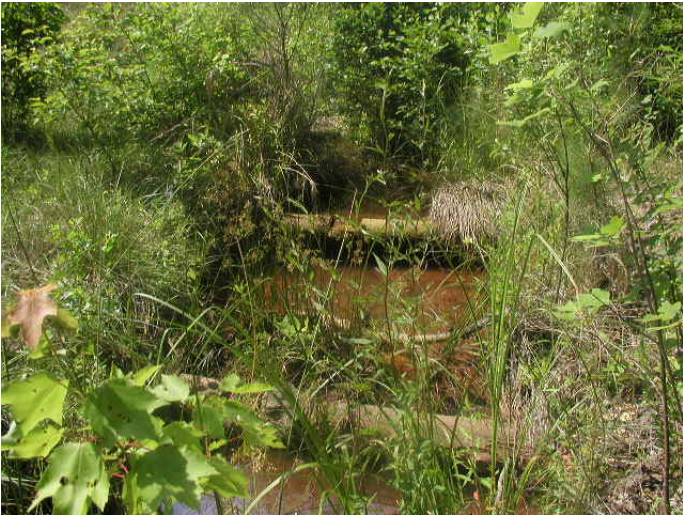
Photo 1 taken from PP# 1 looking upstream

The stream is stabilized for the 5th year of monitoring. At the time of the monitoring evaluation water was still piping under the log vane structure as noted in Photo 1. NCDOT proposes to discontinue stream stability monitoring.

6/3/09	Sta. 51+80 Photo 1	Station Number	Station Number	Station Number	Station Number
Structure Type	Log Vane				
Is water piping through or around structure?	Water is piping under the log vane				
Head cut or down cut present?					
Bank or scour erosion present?					
Other problems noted?

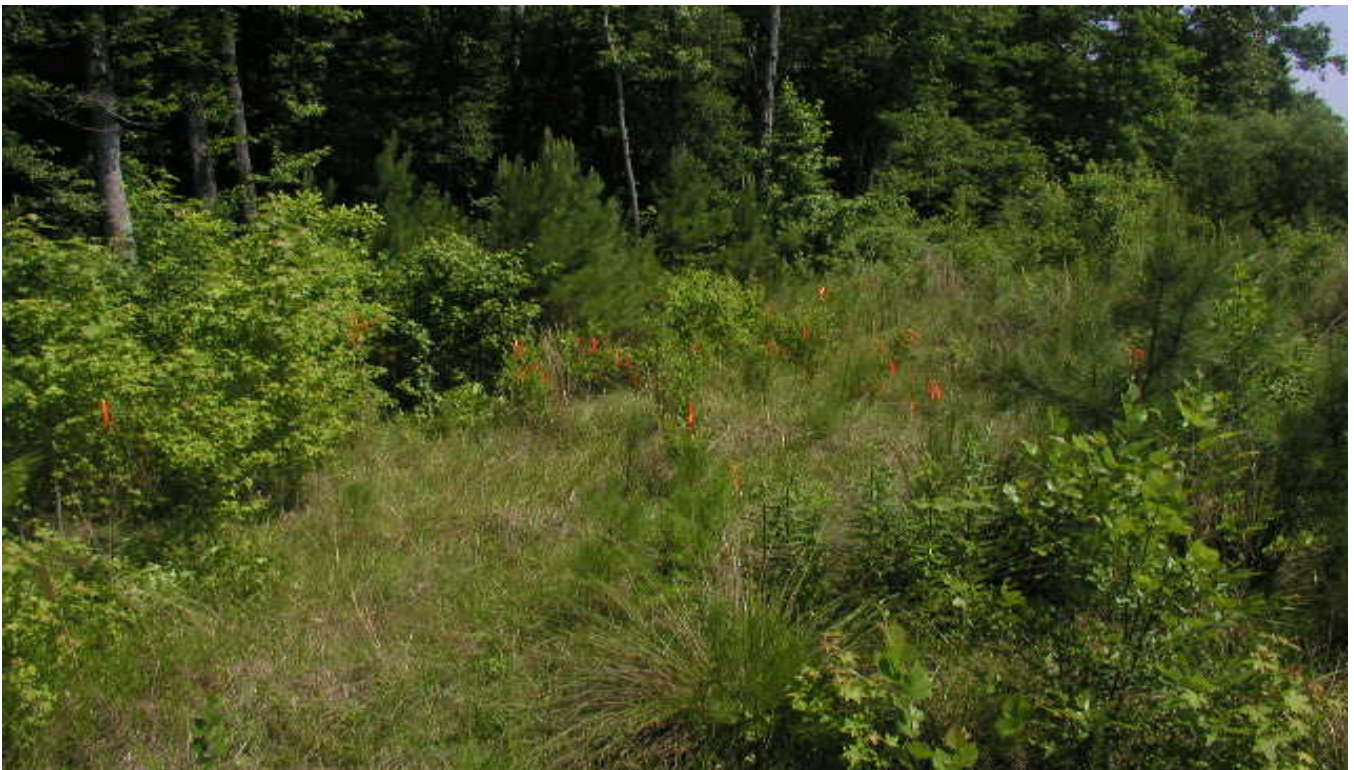
Photo #8 Overview photo taken downstream looking @ vegetation plot

ADDITIONAL COMMENTS: This site was replanted in February 2006 due to low survival rates from the initial planting. The streambanks were live staked with buttonbush and silky dogwood live stakes. The floodplain was replanted with river birch, swamp chestnut oak, and willow oak. Other vegetation noted onsite consisted of black willow, tulip poplar, sweetgum, overcup oak, fescue, woolgrass, fennel, red maple, alder, goldenrod, *Juncus* sp., pine, lespedeza, foxtail, and various grasses. Stem counts were conducted onsite. It was determined that 620 trees per acre are surviving as seen in the table below. Although no willow oaks were recorded in the vegetation plot there were some willow oaks noted surviving onsite. NCDOT proposes to discontinue vegetation monitoring at the UT to Little River stream relocation site.
